# **The 25 October 2005 Surface Thrust Rupture Near Balakot: A Strip of Destruction**

## **Field report June 19-20, 2006**

Nano Seeber, Lamont-Doherty Earth Observatory, Palisades NY 10964

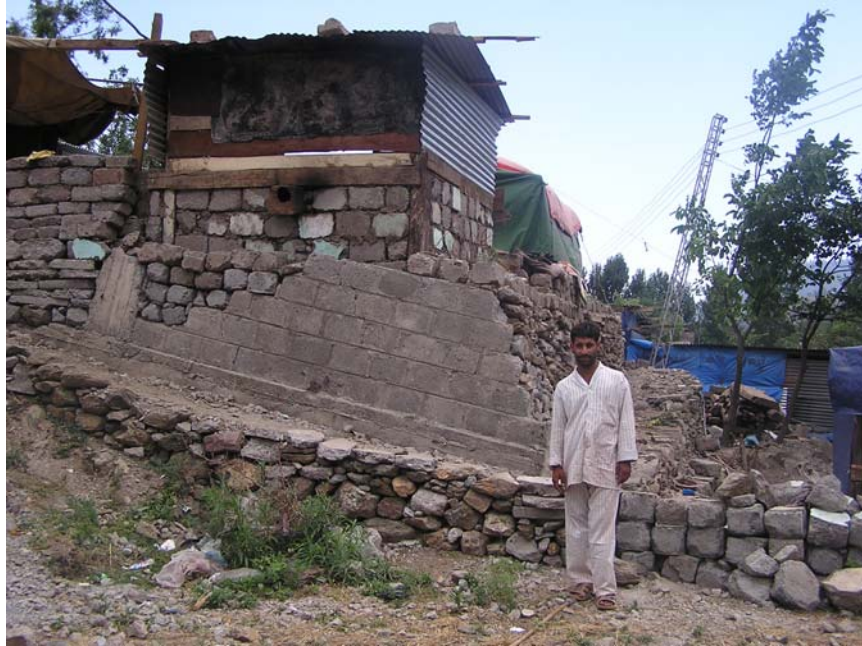
*The strip of destruction through Sarasha Village, 3km northwest of Balakot. The cemented wall, the utility pole, and the trees were tilted 15 degrees by the fault rupture.*

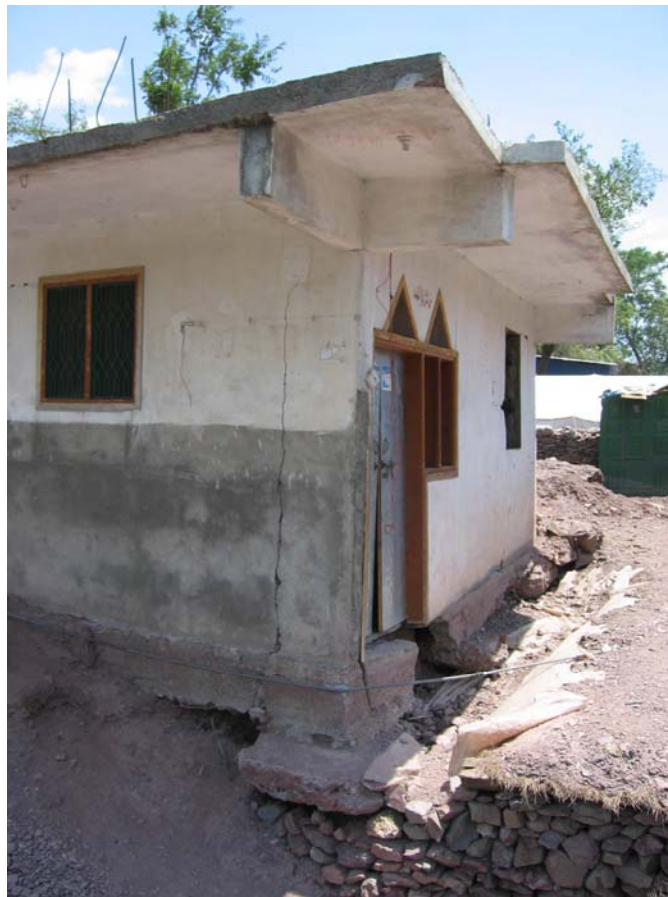
*Sarasha Village: one of the few houses that did not collapse along the strip of destruction. Note fractures widening downward. It appears that this building was damaged by deformation of the foundation, not by shaking.*

1. Coseismic strain, fracturing, and tilting of the hangingwall side of the fault (i.e., permanent deformation in addition to shaking) contribute to foundation failure and destruction.
2. Fracturing lowers seismic velocity, thus increasing the amplitude of shaking.
3. The hangingwall side of the fault is part of the low-velocity channel along the fault and is thus subjected to seismic waves trapped along the fault zone.
4. Seismic wave are amplified along topographic ridges. The ridge at Balakot is the result of accumulated fault motion combined with river erosion on the hangingwall side.
5. Coseismic strain, fracturing and tilting of the hangingwall side of the fault (i.e., permanent deformation in addition to shaking) contribute to foundation failure and destruction.

The relative importance of the various factors is unknown. The remarkable systematics in the level of hangingwall destruction suggests that permanent deformation, rather than shaking was the main factor in the strip of destruction.

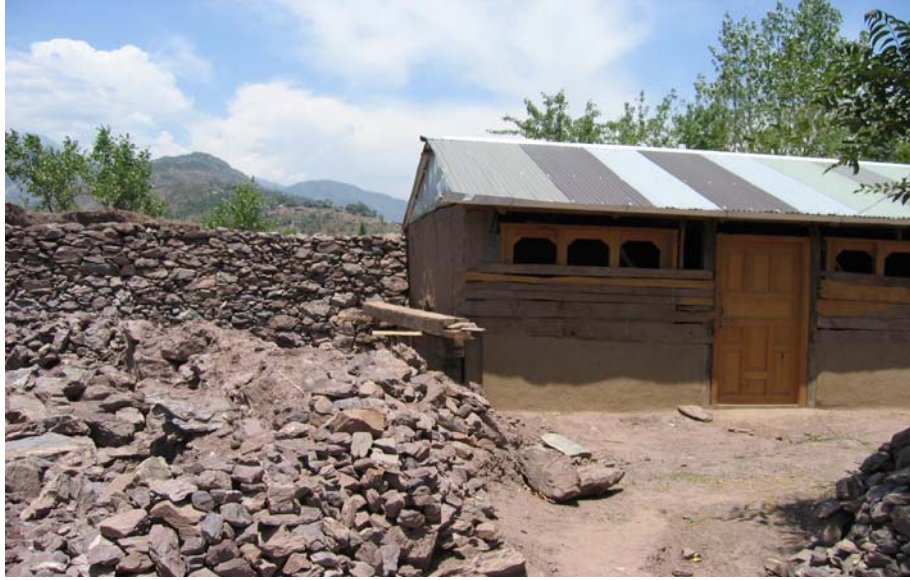
*Reconstructed house on top of hill about 2km northwest of Balakot. The remains of a previous house are on the left. The foundation of the house is bedrock (Murrees formation), but it is on the “strip of destruction” along the hangingwall side of the thrust rupture. No significant modifications from what may be a traditional design were observed, except possibly the large windows covered by temporary planks. No attempt to tie the top of the 2m-tall walls was seen.*

The strong correlation between destruction and fault rupture provides a solid basis for distinguishing areas where rebuilding should not happen, from areas within Balakot where improved construction could provide safe housing and public buildings. The solution for Balakot is not a drastic and unrealistic “moving of the town” but a rearrangement of the town that excludes any buildings from the strip of destruction and from unstable slopes. Other hazards, such as flash-flooding and rock falls need also be considered. The area should be carefully zoned. Tectonic and geomorphic processes associated with thrust faulting, geologic conditions, and a detailed map of the destruction in 2005 are the essential elements to be considered in this zoning. This zoning is important for Balakot and could also serve as a guide for other population centers in similar thrust-fault settings in Pakistan and other regions of active mountain building.

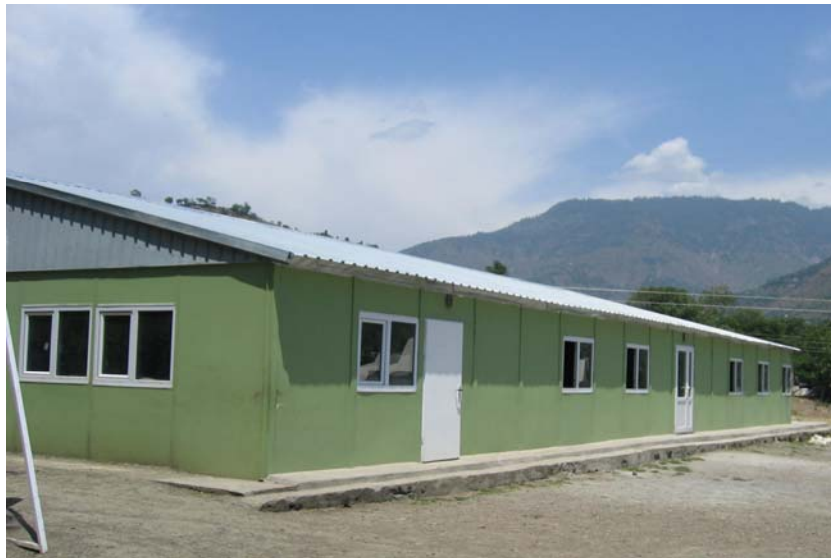
*Light-construction (possibly pre-fabricated) school building in Sarasha village, 3 km northwest of Balakot.*
